Date: 2/6/2020

Goodrich Contoured Diaphragm Flexible Coupling – Touch up Paint and Diaphragm Scratch Evaluation

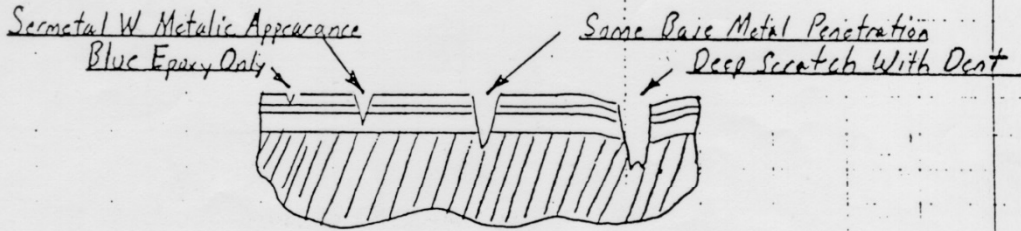
Figure 2 Scratch Cross Section

- 3) Scratches that appear metallic in color at the bottom need to be examined further to determine if the scratch has penetrated the Sermetel W coating – (see Figure 2)

- a) Using fine sand paper, such as 320 grit emery cloth, remove the paint around the scratch. If the scratch disappears at this point, the diaphragm is not damaged - repaint the area with suitable available paint. If not –

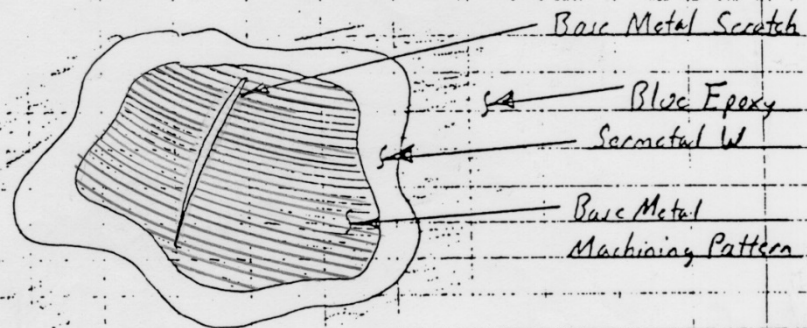
Figure 3 Top View Scratch Area With All Coatings Removed.

- b) Using a soft piece of metal (copper or brass), scrape the Sermetel 'W' away from the area. Because of the color of the Sermetel, it will appear as if metal is being removed. Scrape until a machining pattern appears around the scratch – (see Figure 3). At this point base metal has been reached.

- c) If the scratch has disappeared, the part is not damaged and may be repainted.
 - d) If the scratch still remains, it has penetrated into the base metal. It is important to know the depth of this scratch in order for Goodrich Engineering to determine if polishing can be done to repair.
